POPPLETON HISTORIC STUDY

B-2716 MAGI #0427165404

823-837 Hollins Street

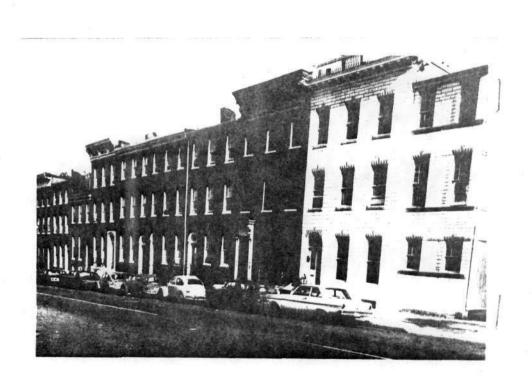
Number 837 has been brutally formstoned and added to. Number 835 is earlier (possibly before 1845) and more handsome than its neighbors; it has a gabled roof with double dormers in the rear. The high cornice was a later addition. These two houses should be rehabilitated and preserved along with the rest of the terrace. Number 835 is city-owned and in need of rehabilitation; it damages an otherwise remarkable terrace.

The group, along with houses across the street, should be considered for rating as a Maryland landmark, the designated area to be from St. Peter's Church to Fremont Avenue, including

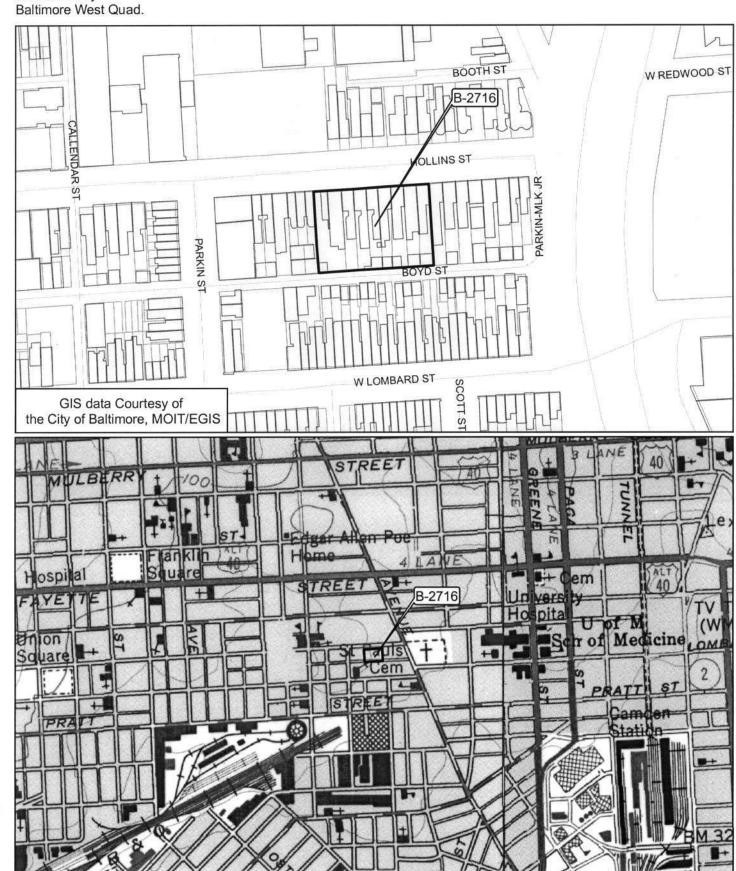
B-2716 823-837 Hollins Street Block 238 Lot 047-054 Baltimore City Baltimore West Quad.

Number 835 is vacant and boarded-up but is the only instance on the entire block, thus it should be remedied quickly. Scale both house-to-house and across-street is excellent. Sizeable street trees should be planted here.

both sides of Hollins Street, blocks 238, 237 and 220, minus the industrial building. The recommendation could include the west side of Parkin Street to Lombard Street.
